Constant maintenance to high performance: Increasing efficiency at the Sturgeon Bay YMCA

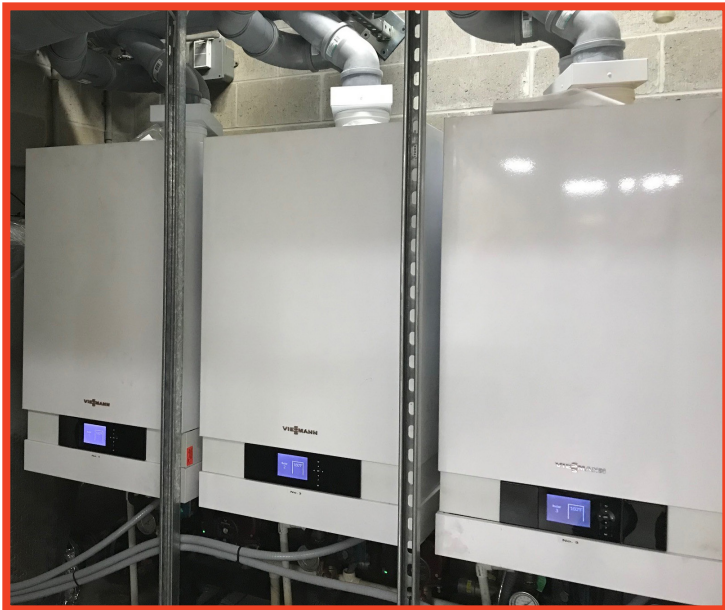
Vitodens 200 Cascade System provides heat for multiple pools at the Sturgeon Bay YMCA

While fighting with control issues across the heating system and other ongoing problems, a heat exchanger in the pool's boiler cracked, leading to the ever-pressing question of whether to [repair or replace the boiler](#). After a cost-analysis, Synergy Geothermal and the Sturgeon Bay YMCA decided to replace the pool's boiler with a highly efficient heating system, and chose a [Vitodens 200 B2HA cascade system](#). With the increase in heating efficiency, the 2 million BTU requirement was reduced to 1.5 million BTUs required to maintain constant heating for the facility's two pools, whirlpool, and water slide.

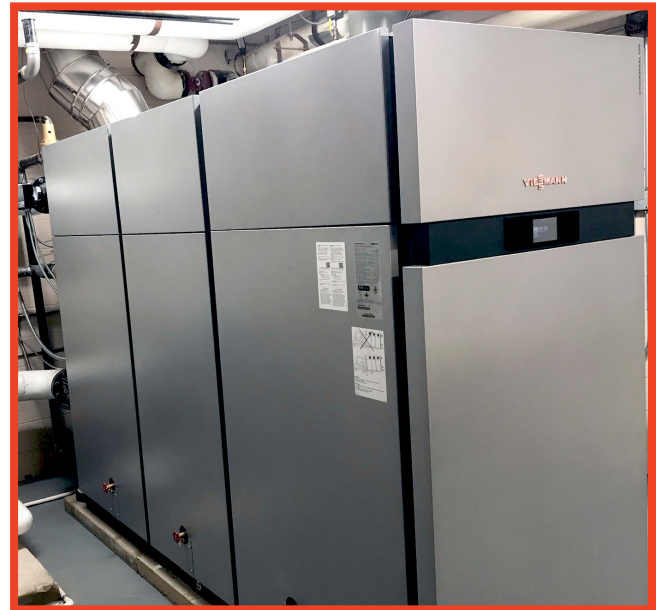
A single Vitocrossal 300 CA3B Provides complete space heating and DHW for the entire facility.

While working on the pool boiler replacement, more questions were raised when a hole was discovered inside the combustion chamber of the space heating and DHW system. A second cost analysis was done, this time in partnership with state initiatives and using rebates available for upgrading heating equipment to high-efficiency, more environmentally-friendly products. With the available incentives, and because the YMCA was in no doubt of maintaining their presence in the community, they decided to move forward with a complete overhaul of the facility's heating system, replacing the two fin-tube boilers and DHW tanks with a single [Vitocrossal 300 CA3B](#), capable of handling 5 million BTUs of heating and hot water output.
